*Presented at the Aerospace / Airline Plating and Metal Finishing Forum in Cincinnati, OH,
March 27, 2000.*

Surface Finishing of Tungsten Carbide Cobalt Coatings Applied By HVOF for Chrome Replacement Applications

*J. D. Nuse - Southwest Aeroservice, Inc., Tulsa, OK
J. A. Falkowski - Boeing Commercial Airplane Group, Seattle WA*

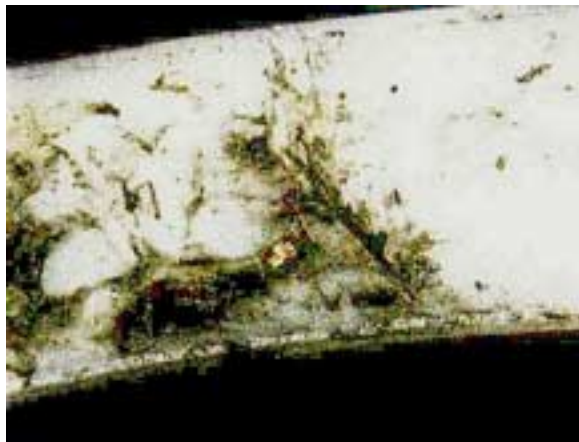
Figure 6 – WC Particles Embedded in Worn Teflon Seal of 737 Nose Landing Gear.

In the case of the 737, a hydraulic fluid sample was retained for analysis. The fluid was first filtered to remove all debris and the residue was subjected to Electron Probe Micro Analysis (EPMA). In addition, a Back Scatter Electron (BSE) image was made to identify the physical make up of the filtered debris. The results of the analysis showed that 5 micron-sized (0.0002 in.) particles of tungsten carbide had been suspended in the hydraulic fluid.

The Teflon seal was examined under magnification and tungsten carbide particles were found embedded in the surface.(Figure 6) This method of analysis is typical of what has been done in the past on fluids from a system containing chrome-plated parts. However, chrome particles have never been detected in the quantity as found with the tungsten carbide and seals have not exhibited the same kind of abrasive wear damage.

The conclusion from this investigation is that 5 micron-sized (0.0002 in.) particles of tungsten carbide were suspended in the hydraulic fluid turning it into an abrasive cutting media. The suspended tungsten carbide particles appear to have no adverse effect on the metal surfaces they are in contact with.

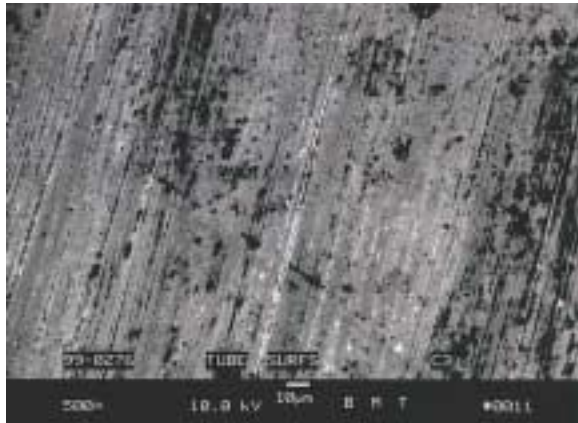
Figure 7 – Hard Chrome Plating Ground to a 0.40 μm (16 μin) Ra Finish (500X).

From a detailed examination of the specimens it was apparent that the surface finish of the ground tungsten carbide coating had different physical characteristics from the chrome plated finish even though they may have the same surface roughness readings. When viewed under 500X magnification the surface of the 0.40 μm (16 μin) Ra chrome plated specimen is much smoother looking when compared to the WC-Co-Cr coating with the same Ra value. (Figures 7 and 8)

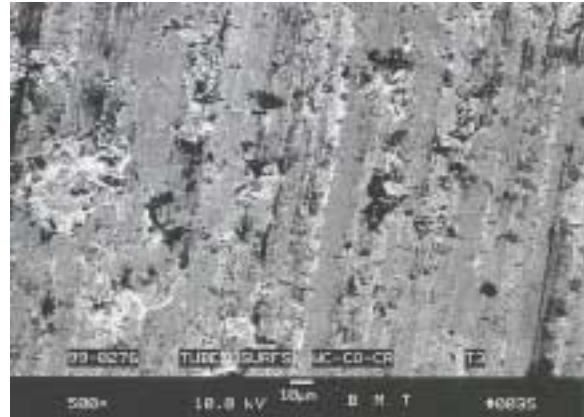
Figure 8 – HVOF WC-Co-Cr Coating Ground to a 0.40 μm (16 μin) Ra Finish (500X).

The grinding marks on the WC-Co-Cr are much larger and there appears to be a great deal of sharp debris just sitting on the surface. It is suspected that this debris is not tightly bound to the surface and that when the part is put into service, this debris breaks off and is suspended in the hydraulic fluid, potentially causing seal damage.

In an attempt to refine the grinding process and reduce the presence of sharp debris, the 0.40 µm (16 µin) Ra HVOF specimen shown in Figure 8 was superfinished to a 0.05 µm (2 µin) Ra value by Supfina Machine Co. Inc., N. Kingstown, R.I. Figure 11 shows the dramatic difference in surface appearance as a result of this process. The depressions in the surface are the natural porosity of the coating and it is felt that these depressions can be sufficient for oil retention without seals running dry because of insufficient lubrication.

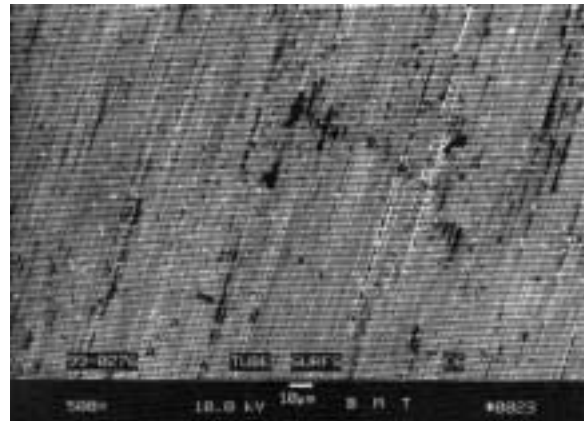
Figure 9 – Hard Chrome Plating Ground and Hand Polished to a 0.05 μm (2 μin) Ra Finish (500X).

Figure 9 shows the original chrome plated specimen that was ground and polished to a 0.05 μm (2 μin) Ra finish. Figure 10 shows the original tungsten carbide coated specimen ground and polished to a 0.05 μm (2 μin) Ra finish. The chrome specimen still appears smoother and there is a definite absence of the sharp debris seen in the 0.40 μm (16 μin) Ra HVOF specimen.
