Case History

Adhesion of Sealers on Thermal Spray Coatings

By John J. Crowe and Michael J. Makosky, G.P.I.

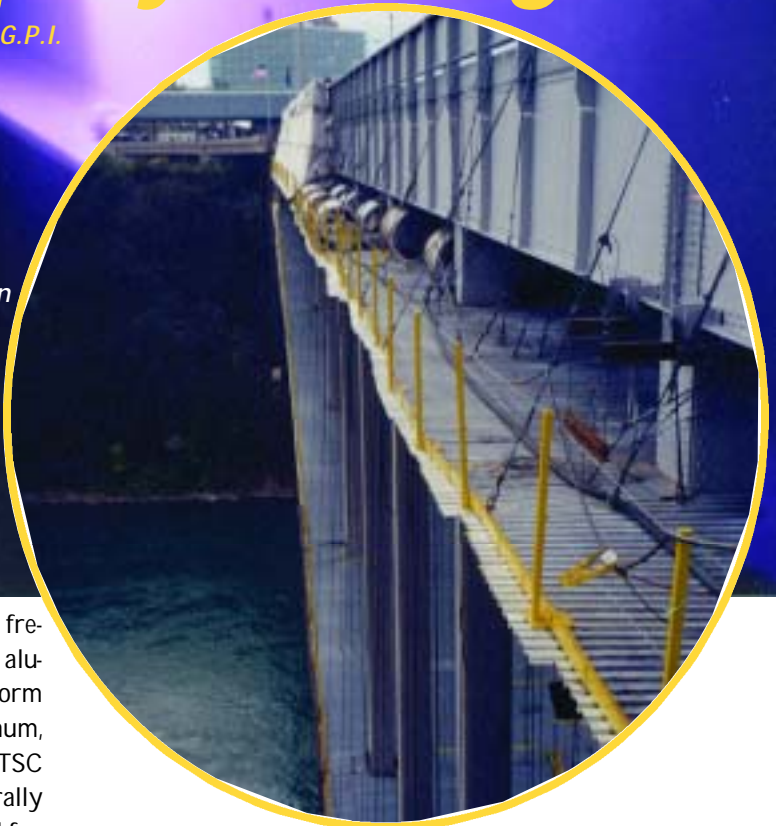
Thermal spraying of Rainbow Bridge component (top) and view of bridge (inset)
Courtesy of Thermion Metalizing Systems, Ltd.

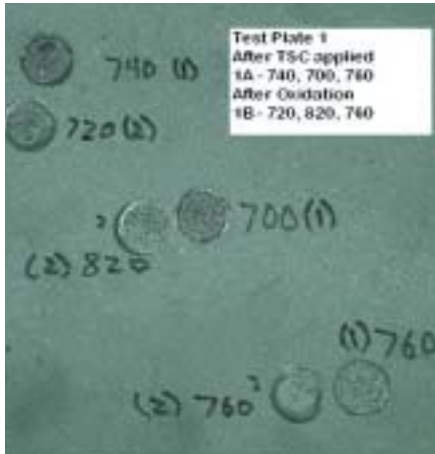
Fig. 1: Plate 1

Plate #1 (Fig. 1) had TSC applied to an average thickness of 12.8 mils; three dollies were placed on the plate and pulled the following day to represent 1A. The average adhesion value of the three was 733 psi, with results of coating adhesion failure to the substrate and cohesive failure within the TSC. The plate sat for three months at temperatures from 65 to 80 F (18 to 27 C) and 50–70% relative humidity (RH), allowing

oxidation of the TSC to take place. Three dollies were once again placed on plate #1 and pulled the following day to represent 1B. The average adhesion value of the three was 767 psi, with results of coating adhesion failure to the substrate and cohesive failure within the TSC (Tables 1A and 1B). There was only a 5% increase in the adhesion values and no change in the failure modes, suggesting that the naturally

occurring oxide sealer formed within the TSC did not have a direct effect on the TSC's adhesion.

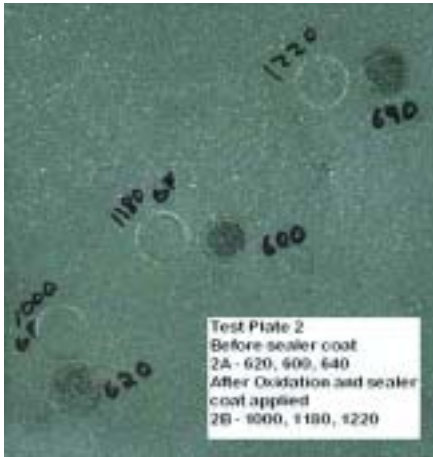
Fig. 2: Plate 2

Plate #2 (Fig. 2) had TSC applied to an average thickness of 12 mils; three dollies were placed on the plate and pulled the following day to represent 2A. The average adhesion value of the three was 620 psi, with results of coating adhesion failure to the substrate. The plate sat for three months (65–80 F [18–27 C] and 50–70% RH), allowing oxidation to take

place. A penetrating seal coat of Corothane I Preprime (cured at 800 F [427 C] and 60% RH) at a thickness of 0.5–1.5 mils (13–38 microns) was then applied. Three dollies were placed on plate #2 and pulled the following day to represent 2B. The average adhesion value of the three was 1,133 psi with 100% adhesive failure (Tables 2A and 2B). These results indicate that the sealer had a definite effect on the adhesion of the TSC, with an increase of 83% in the adhesion values.

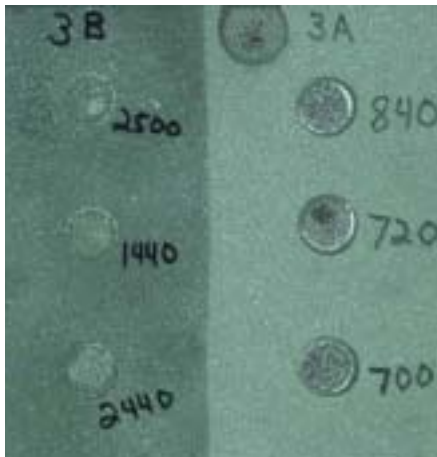
Fig. 3: Plate 3

Plate #3 (Fig. 3) had TSC applied at 10.4 mils. The plate was masked, dividing it into two sections. Sealer was applied to the exposed TSC at 0.5–1.5 mils. After the sealer had cured, three dollies were placed on each section and pulled the following day, the unsealed section representing 3A, and the sealed section representing 3B. The average adhesion value of the unsealed section was 753 psi, with coating adhesion failures at the substrate. The average adhesion value of the sealed section was 2,127 psi with adhesive failure (Tables 3A and 3B). The

increase of 183% in adhesion values with the sealed versus the unsealed section indicates a substantial increase in adhesion values when the sealer is applied soon after the TSC.
