*Presented at the Aerospace / Airline Plating and Metal Finishing Forum in Cincinnati, OH,
March 27, 2000.*

Surface Finishing of Tungsten Carbide Cobalt Coatings Applied By HVOF for Chrome Replacement Applications

*J. D. Nuse - Southwest Aeroservice, Inc., Tulsa, OK
J. A. Falkowski - Boeing Commercial Airplane Group, Seattle WA*

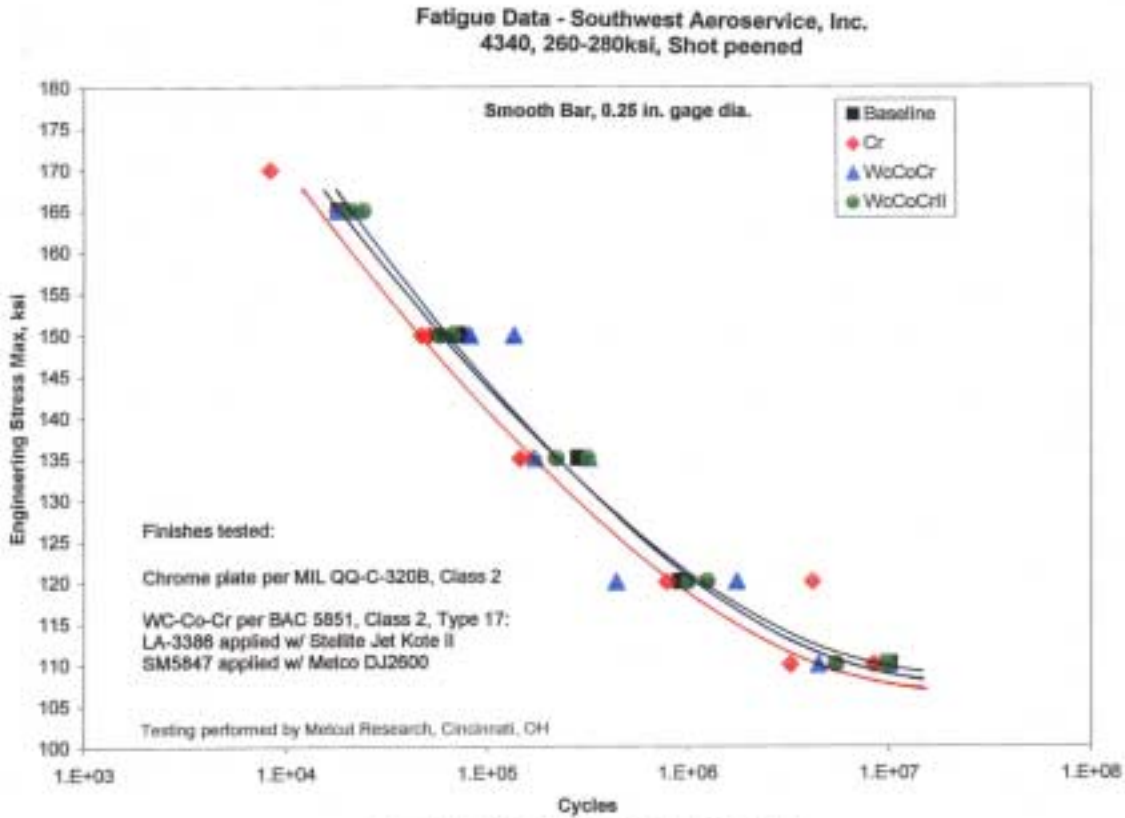
Fatigue testing has generally been conducted by 2 methods: axial fatigue and flexural fatigue. A wide range of specimen materials and configurations has been employed. The example shown in Figure 1 represents the results of a fatigue test comparing HVOF coated 4340 to bare, and chrome plated 4340. All of the specimens were shot peened prior to coating application. The bare baseline was also shot peened.

Figure 1 – Axial Fatigue Results on 4340 Smooth Bar

In this particular test, 2 different HVOF spray systems and powders were used to further investigate coating properties from different material/system combinations. The results show similar results from both sprayed coatings with properties rivaling those of the bare baseline, and better than chrome plate across the range of applied stresses.

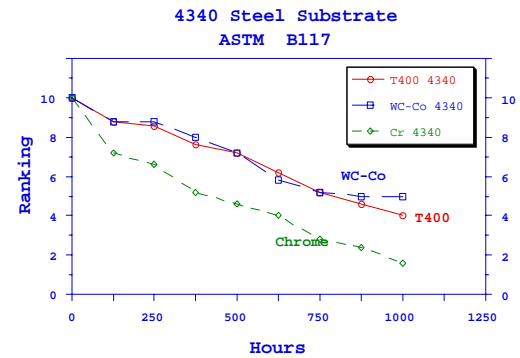
In ASTM B117 Salt Fog Tests using a 4340 steel substrate, results indicate that the WC-17%Co coating performs notably better than the comparative chrome baseline. (Figure 2)¹

Figure 2 - Appearance rankings for coatings on 4340 steel substrates subjected to ASTM B117 cyclic test.

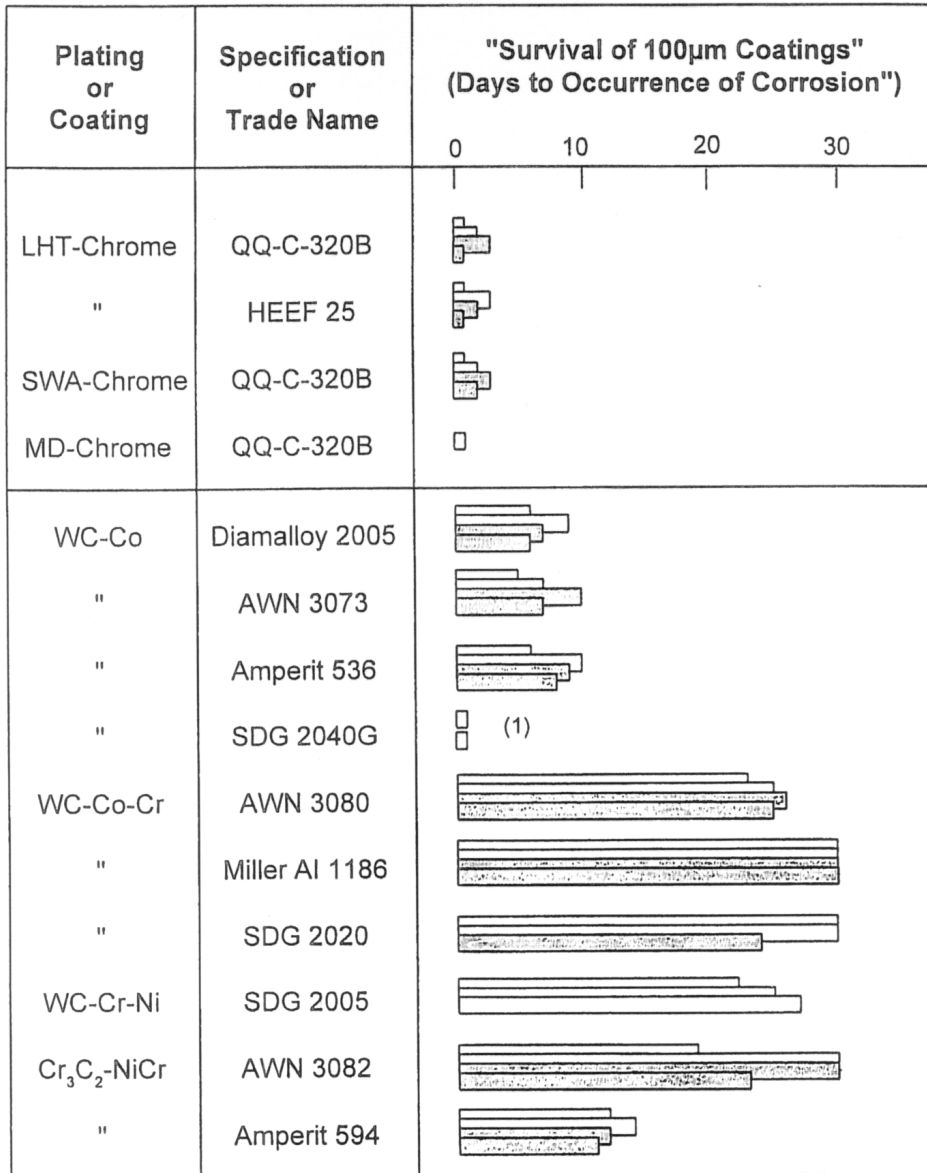
Other corrosion studies undertaken by organizations such as Lufthansa Technik also evaluated the other HVOF material of choice for chrome replacement: 86%WC-10%Co-4%Cr. In their study, the WC-Co-Cr performed not only better than chrome plating but also better than the WC-17%Co material. (Figure 3)² This has led some users to select the coating with 4% chrome content for additional protection in highly exposed and vulnerable areas. It should be pointed out, given the environmental concerns regarding chrome, that the chrome content

(1) Two sets with two specimens each (a total of four specimens) had been tested within two test runs showing the same result, i.e. failure after one day.

Figure 3 – Lufthansa Corrosion Testing of Chrome Plating and Thermal Sprayed Coatings

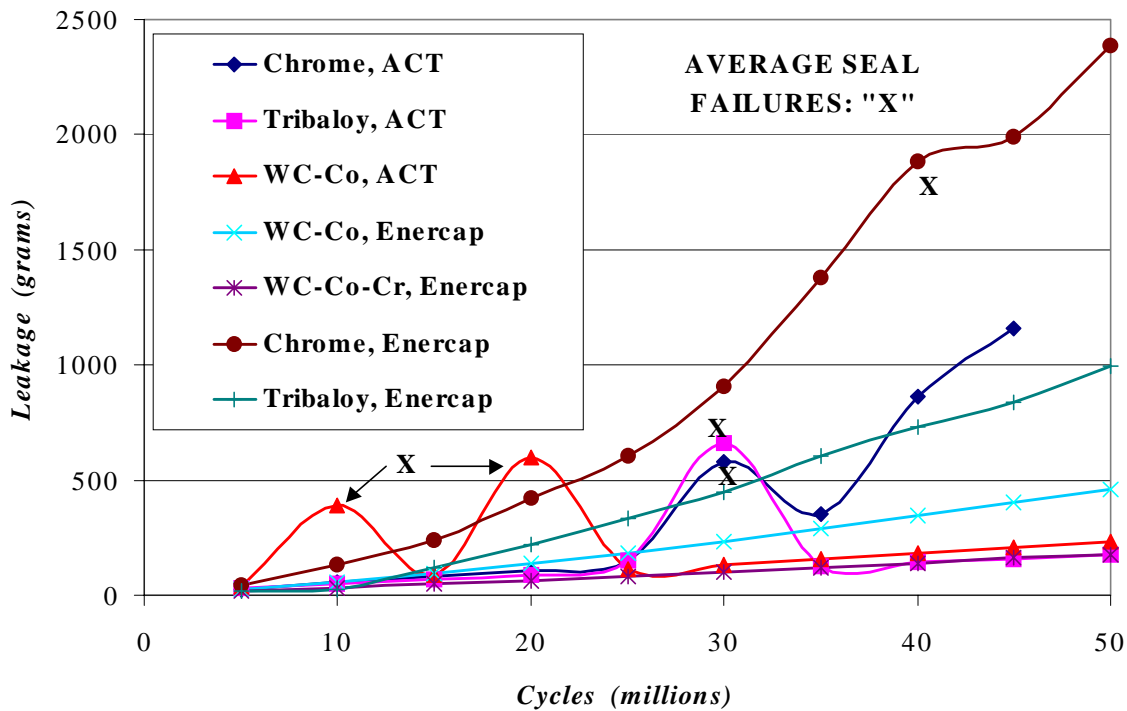
Figure 4 – Greene, Tweed & Co. Seal Wear Study on Chrome Plating and HVOF Coatings

Of particular interest in sliding hydraulic seal wear applications is the effect of the HVOF coating on seal life. Studies conducted by seal companies like Greene Tweed have demonstrated that when HVOF

is mated with the proper seal material, it can significantly improve seal life over that obtained on a chrome plated surface. (Figure 4)³

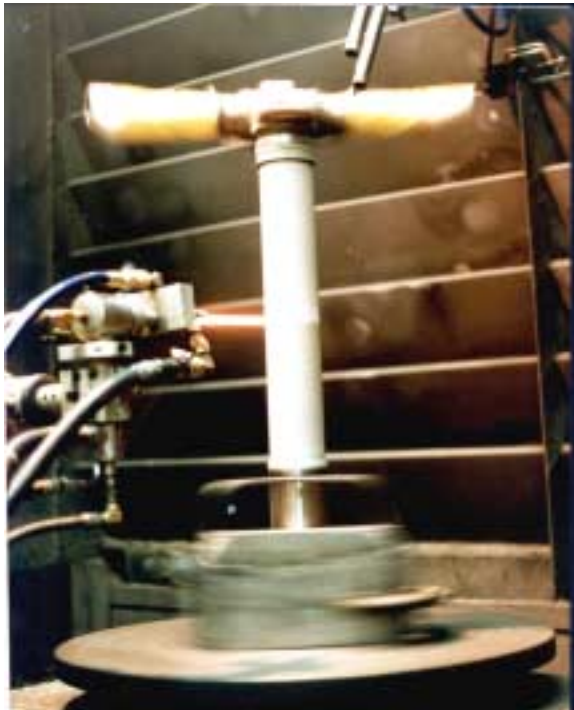
Lufthansa put the first-ever HVOF coated B737-300 NLG inner cylinder into service on January 3, 1996 for a two year evaluation. The cylinder was coated with WC-17%Co applied by Southwest Aeroservice, Tulsa, OK. (Figure 5) Lufthansa was motivated by environmental concerns as well as processing issues related to chrome. Typically the process flow time is six days for the chrome plating cycle on this part. That is because of the need for special masking and supplementary anodes to plate the cylinder and then the axles. This process flow time is reduced to less than four hours when applying an HVOF coating resulting in a significant life cycle cost reduction for the part.

Figure 5 – Application of HVOF Coating to 737 Nose Gear Inner Cylinder

The cylinder went into service with a surface finish of 0.10 to 0.15 μm (4 to 6 μin) Ra. The cylinder was then inspected at 6-month intervals throughout the period of evaluation. This inspection consisted of raising the nose of the airplane to achieve full extension of the gear. The wheels and the

bearings were removed and a penetrant inspection (red dye check) was performed to detect possible cracks. No rejections were found during the dye checks. All surfaces were inspected for visible defects such as chipping, flaking of the coating, and wear marks but no defects were found.

Lufthansa has traditionally replaced seals after 900-1100 flight cycles. During this evaluation seal life was extended to 1910 flight cycles. The cylinder was removed in April 1998 after completing 4701 flight cycles. The cylinder was inspected for visible defects similar to the 6-month inspections and no defects were found. Surface roughness had increased to an average of 0.25 μm (10 μin) Ra with a brownish discoloration evident on the surface due to imbedded particles of Teflon from the seal.

A fluorescent penetrant inspection (FPI) showed indications on the aft side of the cylinder that were not readily apparent with the dye check used at the 6-month intervals. Upon magnification the fluorescent streaks were in fact small crack like indications. In an effort to determine the extent of this cracking the cylinder was returned to Boeing, Seattle for a Barkhausen inspection.

The Barkhausen test measures the stress presence in the substrate using a generated magnetic field. If cracks had indeed continued to the substrate, as in the case of chrome plate, the Barkhausen would have shown a reading to that effect. Since it was determined that these indications did not go all the way to the substrate it was concluded that the cracks themselves were confined to the thickness of the splat layer. The only way to confirm this suspicion is to cross section the part where the indications are and examine them under the microscope. Since the Barkhausen tests did not warrant this the part was returned to Lufthansa for continued service. The cylinder was returned to service on 21 August 1998. Another inspection of the component was conducted on the aircraft on 21 September 1999 with no structural defects noted.
